Lightning Activities in the DOE-EPRI Turbine Verification Program

*Presented at the American Wind Energy Association's
WindPower 2000
Palm Springs, California
April 30 - May 5, 2000*

LIGHTNING ACTIVITIES IN THE DOE-EPRI TURBINE VERIFICATION PROGRAM

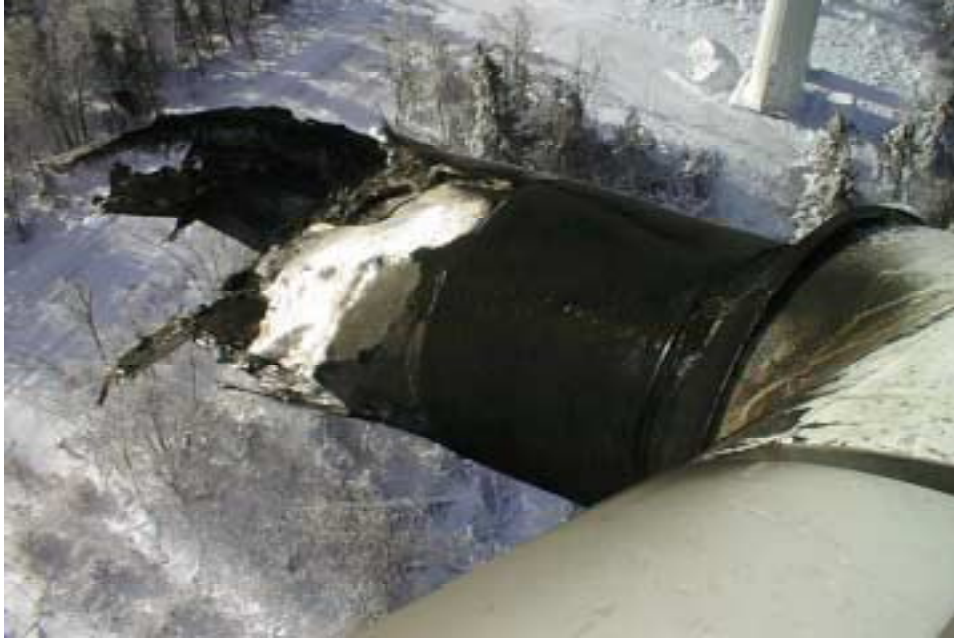
The Searsburg site experienced a second blade failure from a direct lightning strike on January 11, 2000, as shown in Figure 5. The Big Spring project was not fully operational until late in 1999 so it is not included in these tables. Also, the Wisconsin turbines did not suffer any appreciable lightning damage or downtime, presumably because of the protection afforded by tall communications towers nearby and good shielding techniques in the turbine controls.

Figure 5. Blade damage at Searsburg, VT

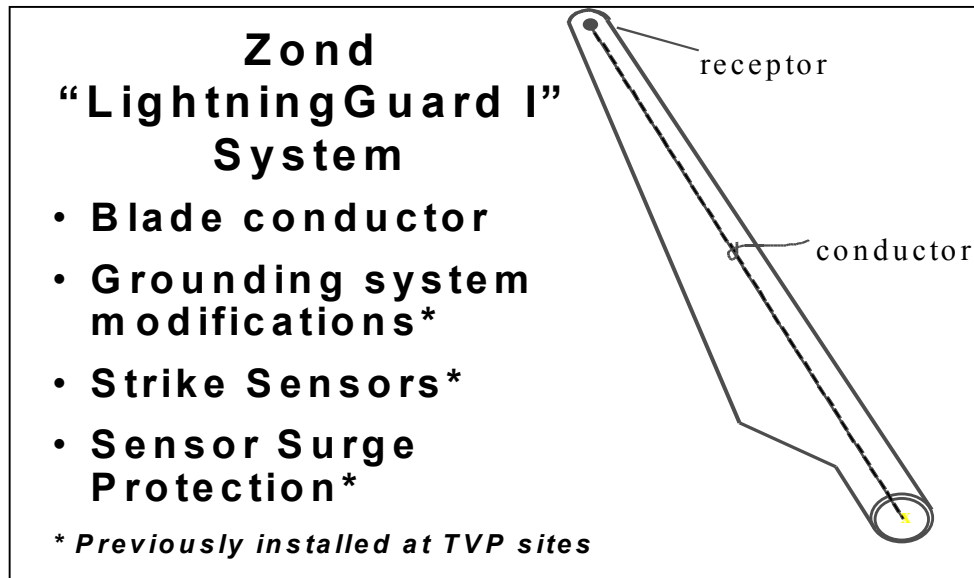
Figure 6. Z-50 “LightningGuard I” retrofit

One of TVP's primary findings was that the Zond turbines had no blade conductors, except for the Z-40A, which has an aluminum push rod in the blade to actuate the ailerons. The Tacke and Vestas turbines both had blade conductors designed for lightning protection. Both of the Zond turbine models without blade conductors have suffered lightning-related blade damage. Zond recently developed and tested a retrofit for the Z-50 blades, and installed conductors in Algona and Springview this spring. Shown in Figure 6, Zond's "LightningGuard I" conductor retrofit consists of a copper tube that is fed through the interior of the blade, held in place with expanded foam blocks and connected to surface-mounted air terminals at the blade tip.

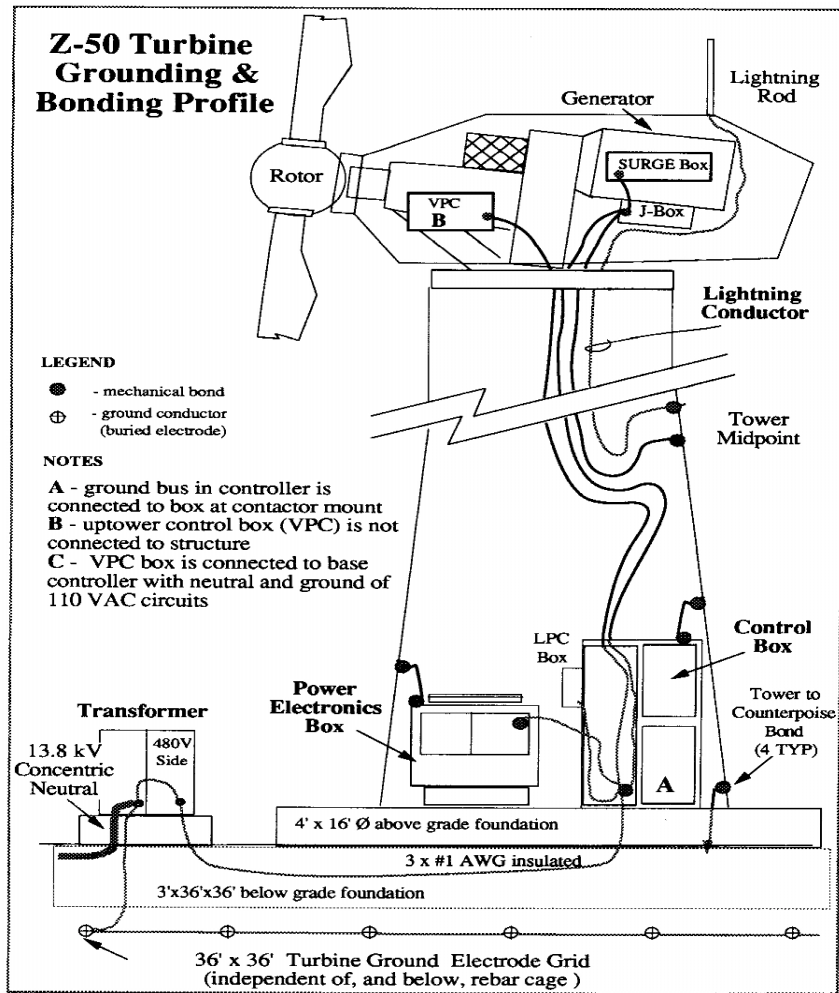
Figure 7. Lightning protection for Z-50s in Algona, Iowa and Springview, Nebraska

A variety of other retrofits were identified and implemented on the TVP turbines. These included improvements to the turbine grounding and the controller cable shielding. Figures 7 and 8 show additional modifications made to the Z-50s in Algona and Springview and to the Z-40A turbines in Ft. Davis. The recommended modifications to the Z-40FS turbines in Vermont are similar to those shown for the Z-50. These retrofits typically involve improving the grounding path through the turbine structure, shielding the sensor cables, and improving the earth ground at the foundation. On the Z-40FS and Z-50 turbines, the controller cable shielding was connected at the entry point of the controller enclosures and copper over-braid shield was provided in critical locations such as the anemometer cable.

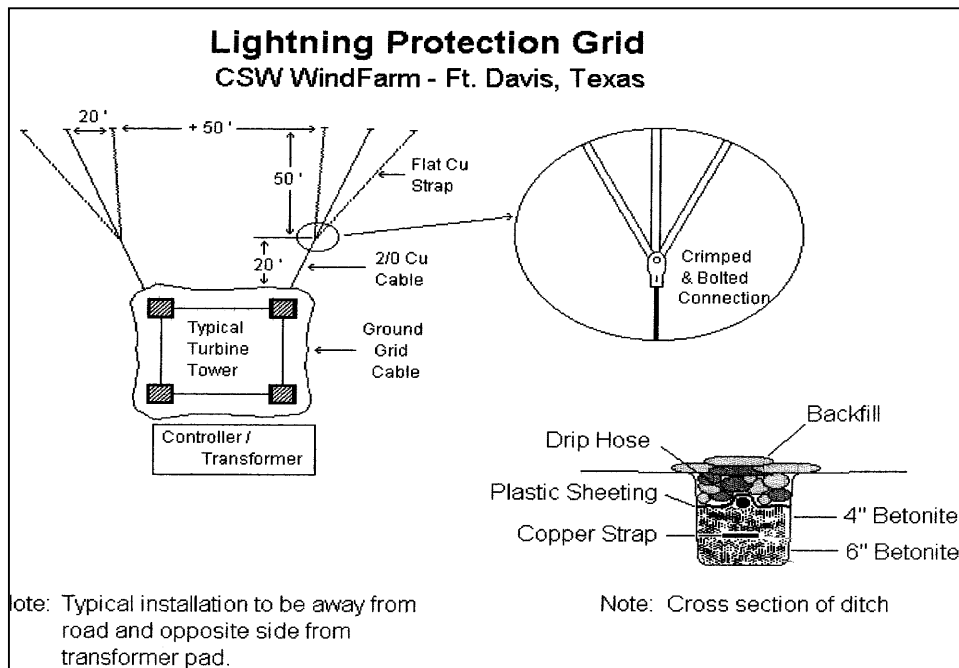
Figure 8. Lightning protection grounding grid in Ft. Davis, Texas

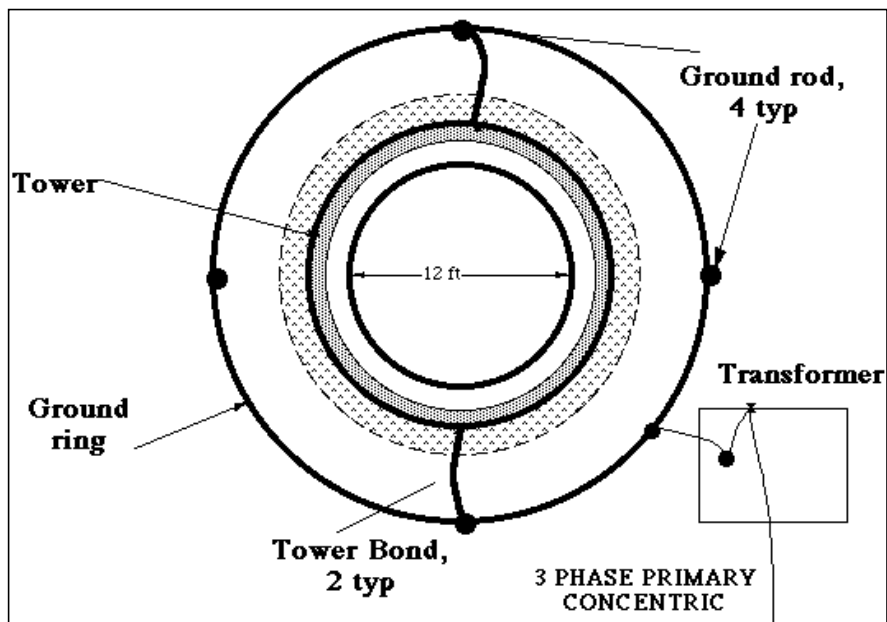
Figure 9 shows the earth-grounding arrangement in Big Spring. Vestas' lightning protection is a continuous grounding system, extending from internal blade conductors through the concrete foundations. Based on the experience of local electricians, Big Spring's project owner, York Research, installed lightning arrestors at each turbine transformer and in the overhead power lines in response to lightning-related interruption of radio communications during initial project operation.

Figure 9. V-47 and V-66 foundation grounding schematic at Big Spring, Texas
